PHASE I ENVIRONMENTAL SITE ASSESSMENT

**1050 WASHINGTON AVENUE
NIAGARA
MARINETTE COUNTY, WISCONSIN**

August 18, 2023

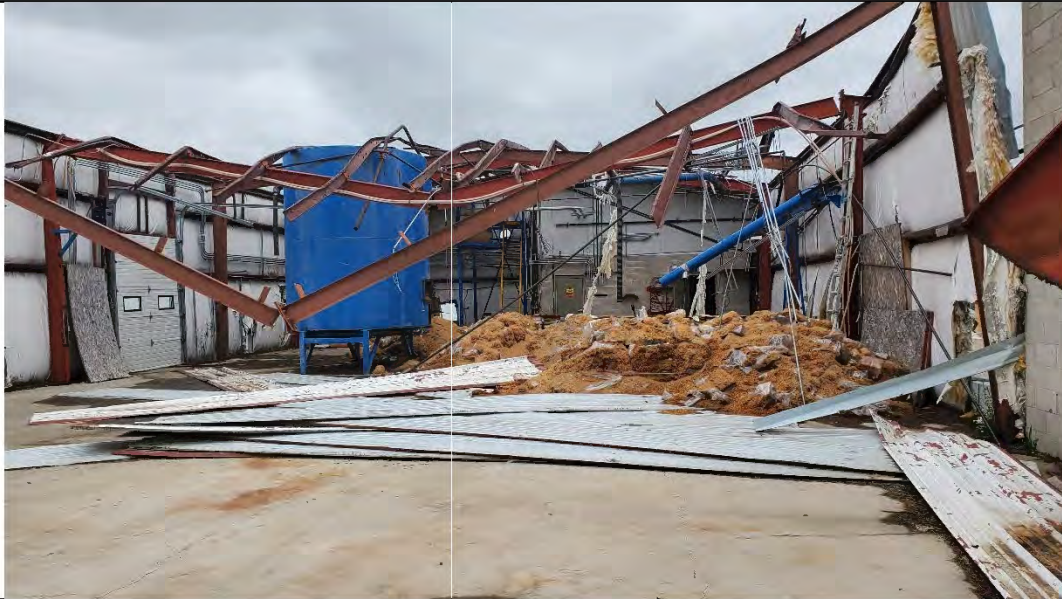
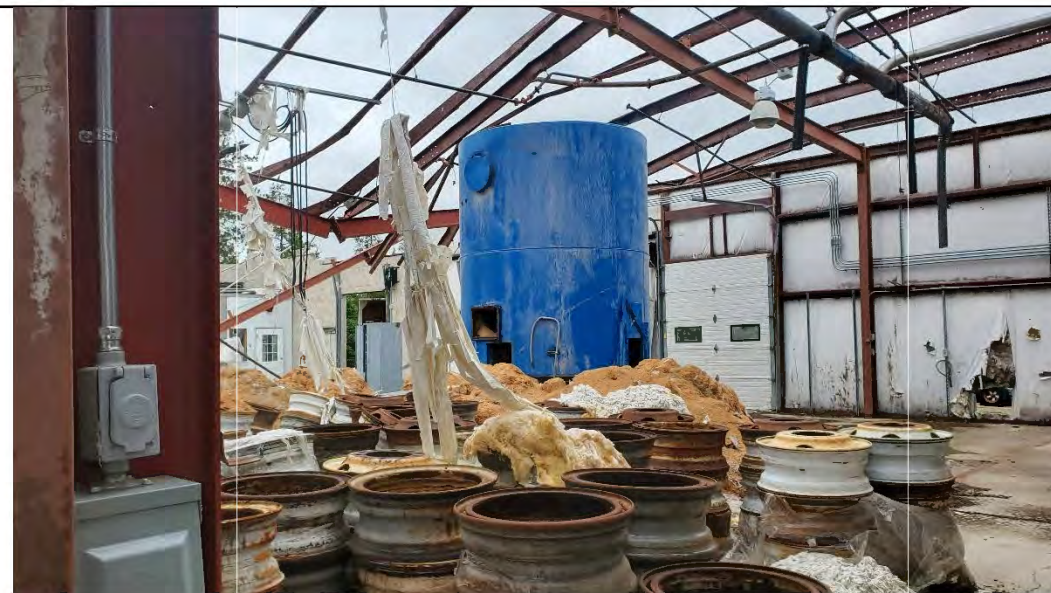
The pellet mill is a partially demolished structure on the southwest side. There are two connected buildings; a block building and a metal construction with concrete floors. There is a wood beam construction metal sheathed three-sided shed just south of the block building. Most of the equipment has been removed and the structure now contains truck tire wheels, sawdust and an old sawdust silo. A floor mounted dry style transformer was observed in the block building. One end of the block building was removed to remove equipment. The shed held a trailer used to transport sawdust.

View inside Former Pellet Manufacturing Plant

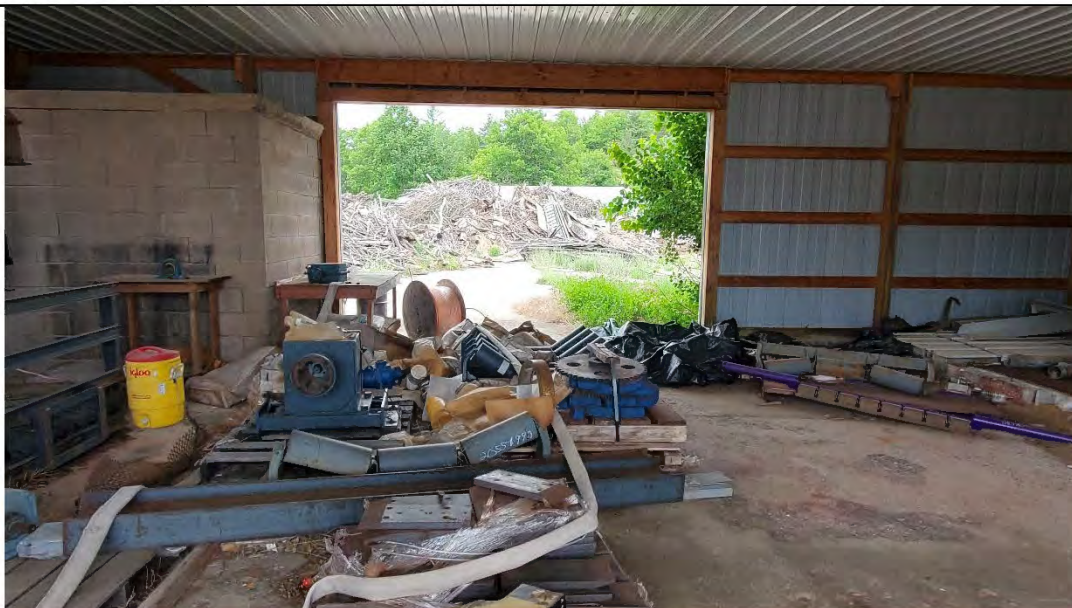
In the maintenance building section of the chipping operation were a work bench and gallon and -5gallon containers of petroleum lube products. No staining or floor drains were observed.

View North in Chipper Building

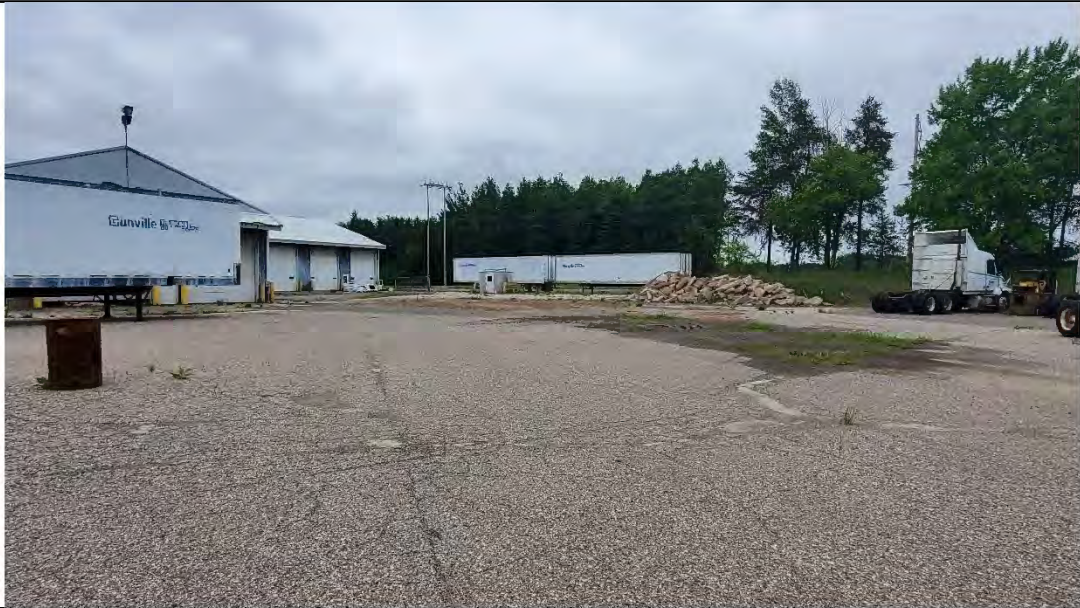
View Northwest to former USTs Location

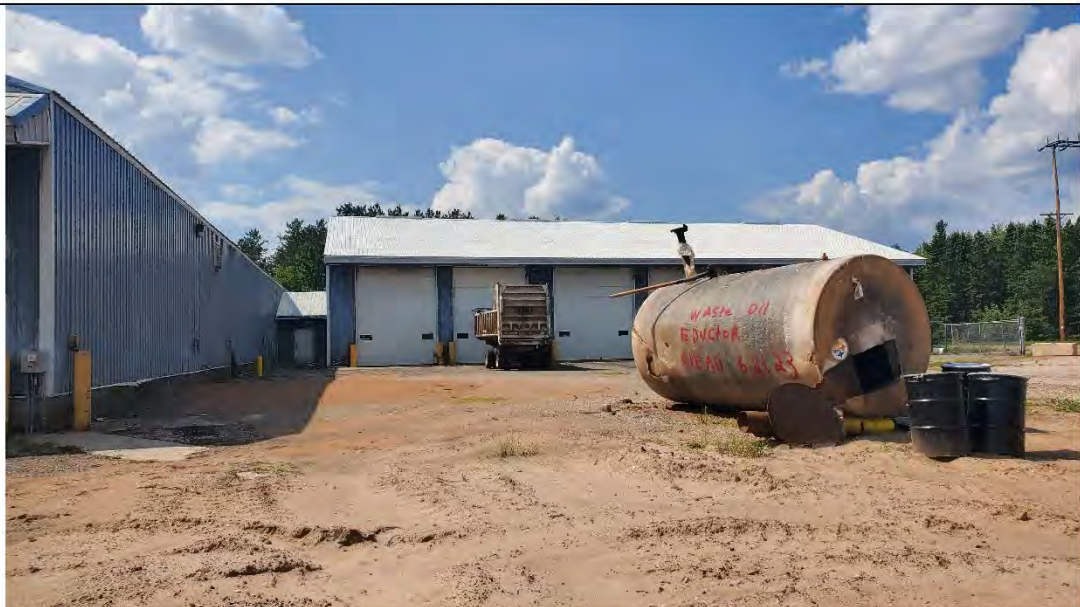
View West of Former Used Oil Tank Location

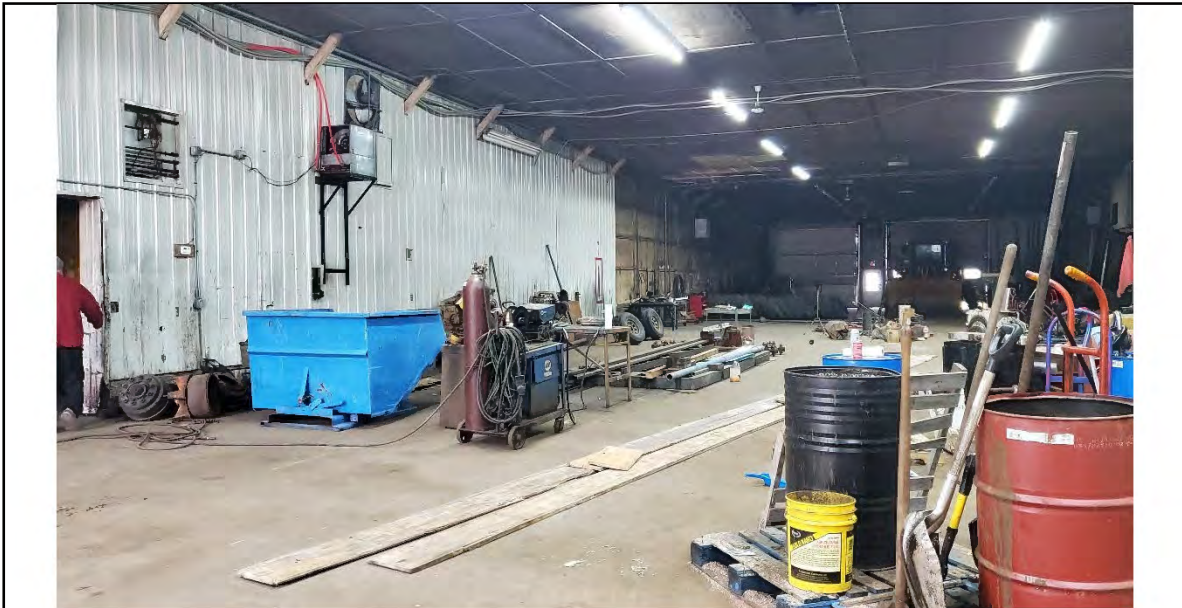
The trailer bay is a pole barn structure running the full length of the north side of the office and parts room, with access to both. The bay has two rollup garage doors on each end. The inside includes the fluids and equipment required to maintain trailers. drums of petroleum lubricants, cylinders of welding gases, a part washing barrel, and grease containers were observed. Trench drains were observed in front of the roll up doors. In the walk-through area between the Trailer Bay and the Tractor Bay were two

View East of Trailer Bay

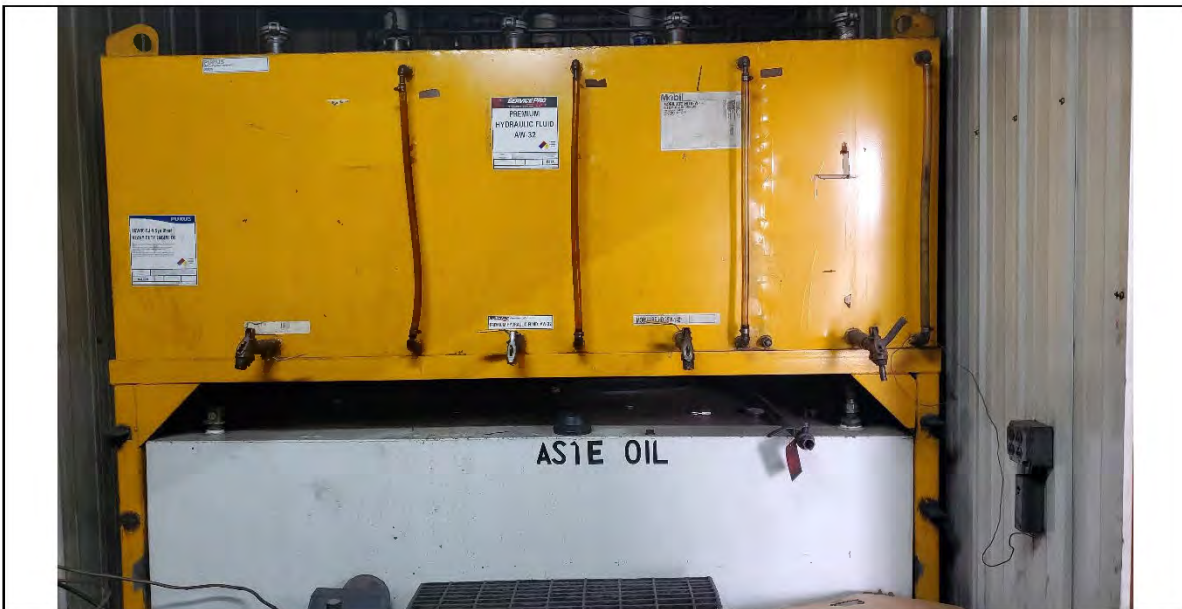
No active outdoor aboveground storage tanks were observed on site. There are oil storage tanks in the walkway between the Trailer and Tractor Repair Bays.

View of Oil Storage between Trailer and Truck Bay

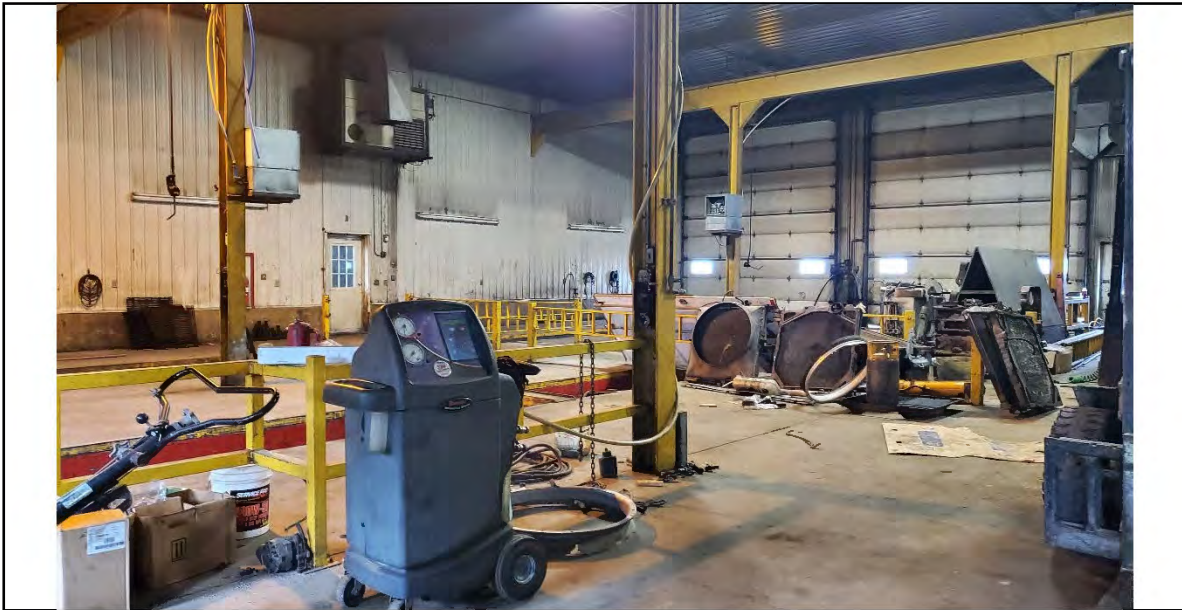
The tractor bay, north of the trailer bay, is also a pole building with metal siding above 3-foot concrete walls but only half as long. The floor of the bay has several pits for working on trucks. One pit had three tractor engines in it. Trench drains were observed in front of the doors. A forklift, dump trailer and 4-wheeler were observed. No severe stains were observed.

View Northeast in Truck Bay

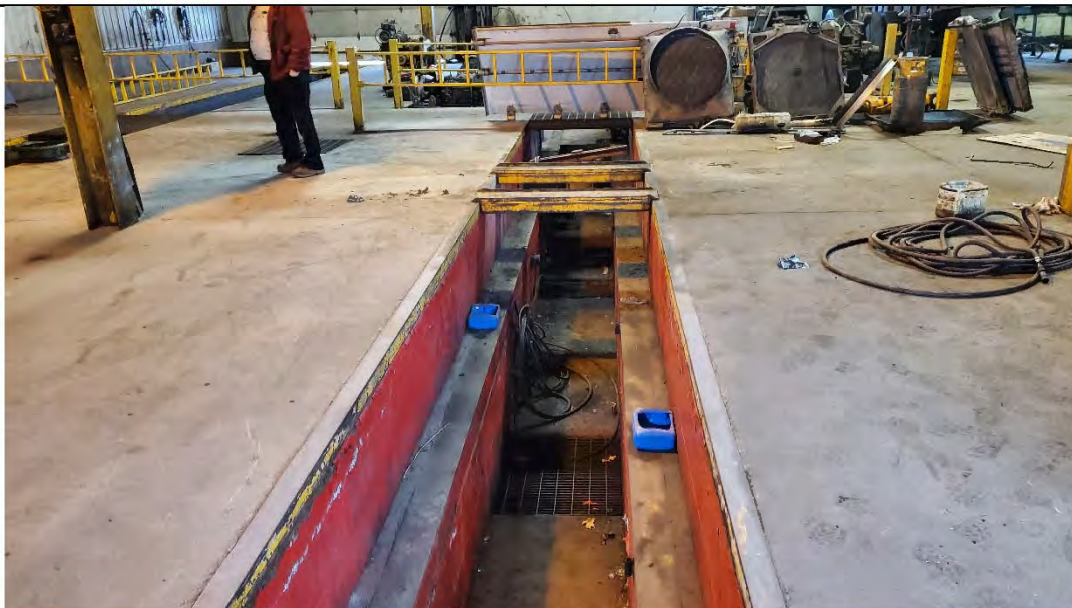
View East of Service Trench in Truck Bay

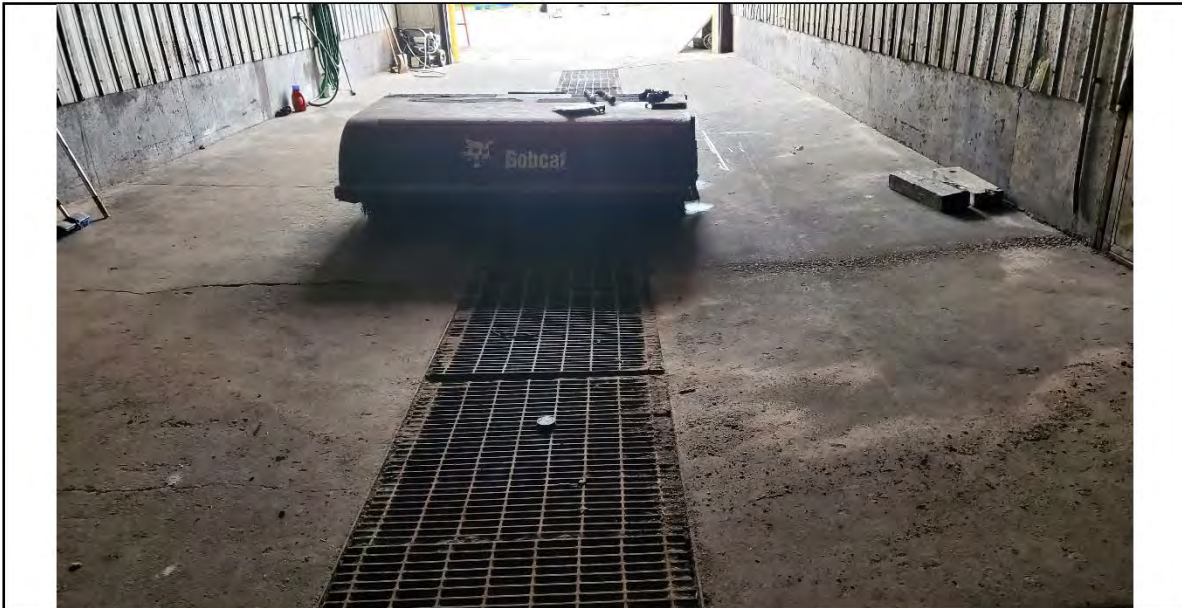
The wash is of the same construction as the Tractor Bay but has a pit in the center for sand and grit. There were no stains observed.

View East of Wash Bay

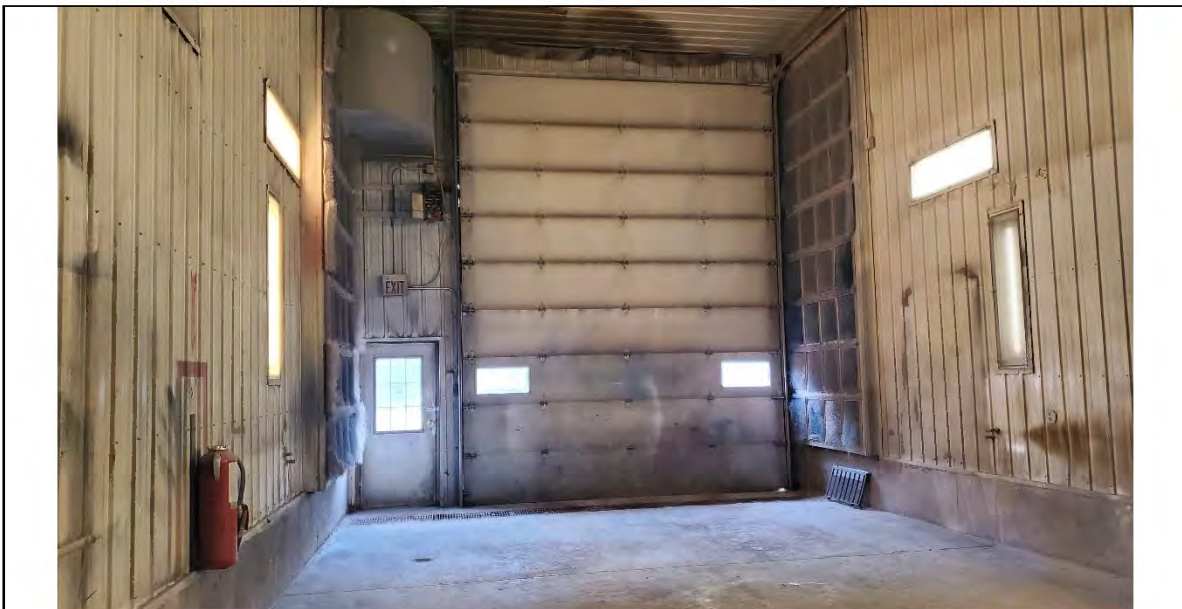
Of similar construction as the Wash and Tractor Bay, the paint bay has lighting on the side to illuminate the projects and dry them. A table was observed with two metal quart containers of Xylene, a 5-gallon pail of multipurpose solvent and a 5-gallon pail of 303 tractor fluid. Again, no stains were observed.

View East of Paint Bay
